Article

Methodology for the Study of the Envelope Airtightness of Residential Buildings in Spain: A Case Study

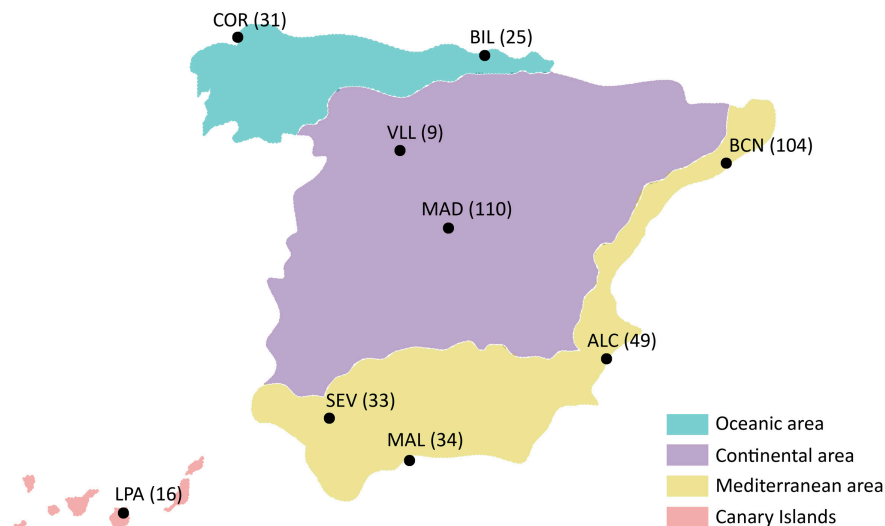
Figure 1. Considered climate zones in Spain, location of the participant Universities, and size of the sample of each of them.

The climatic zone also has a significant impact on airtightness. Buildings located in cold climates tend to be more airtight than others located in temperate climates [41]. Climatic zones do not only affect weather conditions, but they can also establish differences in regulatory requirements or different construction systems [28]. A simplification of the climatic zones in Spain has been made, obtaining a total of four zones: Continental, Oceanic, Mediterranean, and Canary Islands (Figure 1).

A total of nine universities (Figure 1) participated in the characterization and testing of the required cases. To this end, testing campaigns have been organized throughout 2016 and 2017, taking into account the number of cases assigned to each site and paying special attention to the expected climatic conditions, given that the EN 13829 standard [45] determines limitations with respect to the wind during the test. Each site consisted of a coordinator and one or two teams of technicians, with a total of 11 teams to cover the field work. These teams were trained before the campaigns to ensure proper compliance with the developed protocol. A common cloud server was created to allow constant data transfer and supervision from the coordinating University (VLL).

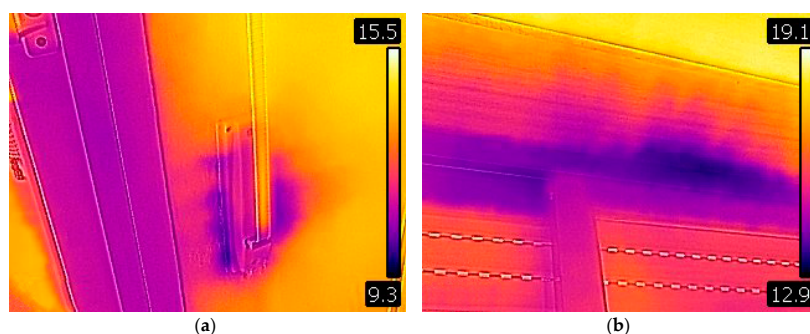
Figure 3. Usual leakage paths detected with thermography. (a) Leakage path at the strap coils of rolling shutters; (b) Leakage path at window joints.

During the depressurization stage, leakage points were identified by thermography (Figure 3). However, due to the climatological conditions of the areas where the tests were carried out, a large thermal gradient to allow thermographic observation was not always expected. In these cases, thermography will be replaced by the use of smoke generators.

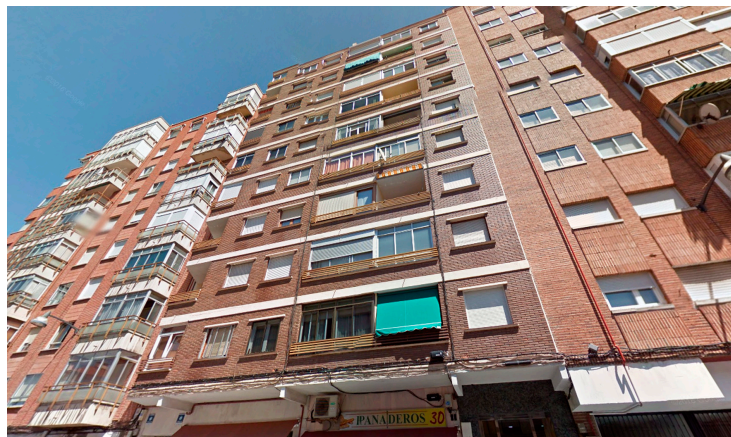
Figure 8. Exterior image of the case study 09683460651630036.

A case study is presented in order to show the implementation of the designed methodology. An apartment located in the city centre of Valladolid (Figure 8) has been chosen due to its representativeness of the residential building stock in Spain (case 09683460651630036). The climate of Valladolid belongs to the “Continental” area of the country and it is classified by CTE as D2 area.

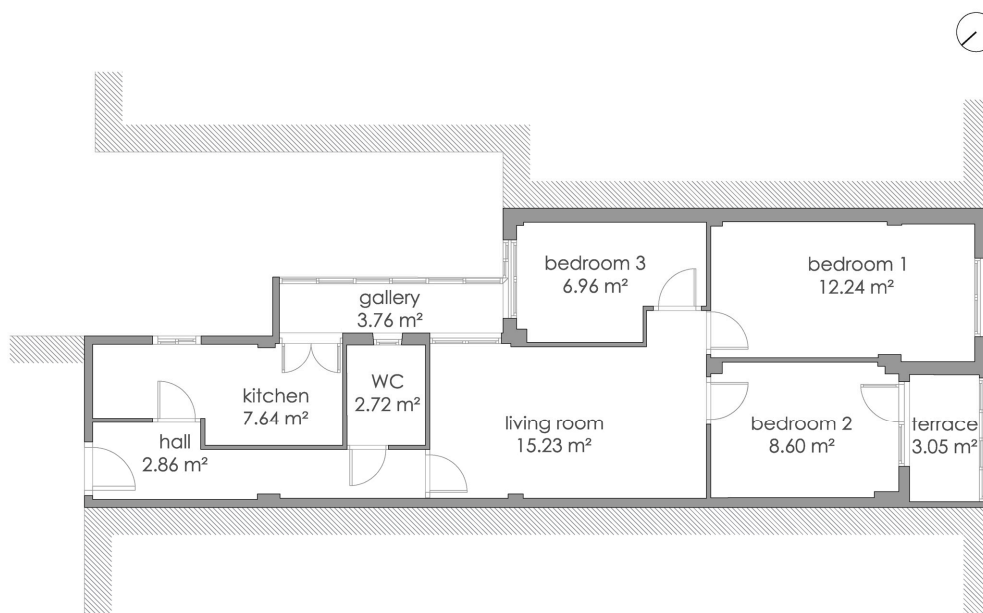
Figure 9. Floor plan of the dwelling.

The building was constructed in 1968, before regulations in Spain considering energy losses were implemented. The building consists of 9 floors and an attic. The apartment is on the ninth floor and has a south orientation in its main façade to Padilla Street and a secondary façade to a wide internal courtyard with east orientation (Figure 9). All the specifics are detailed in Table 7.

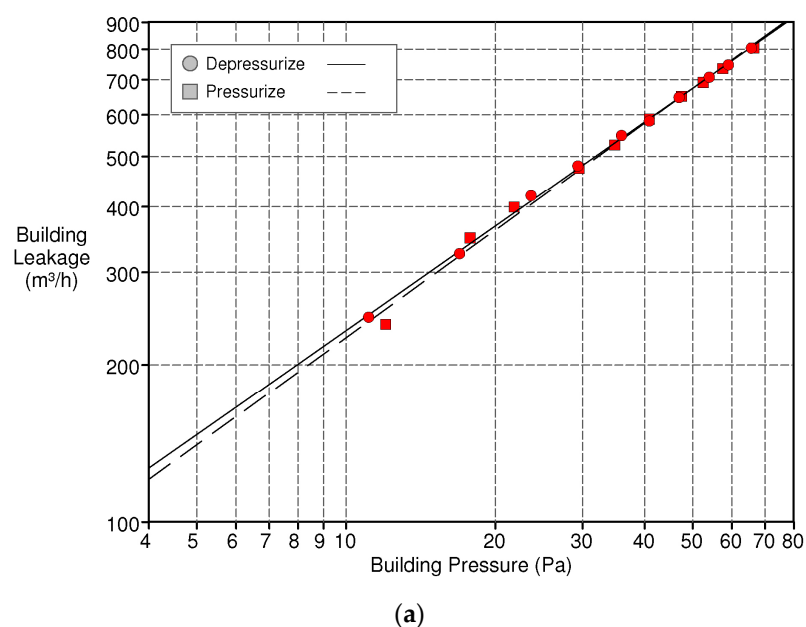
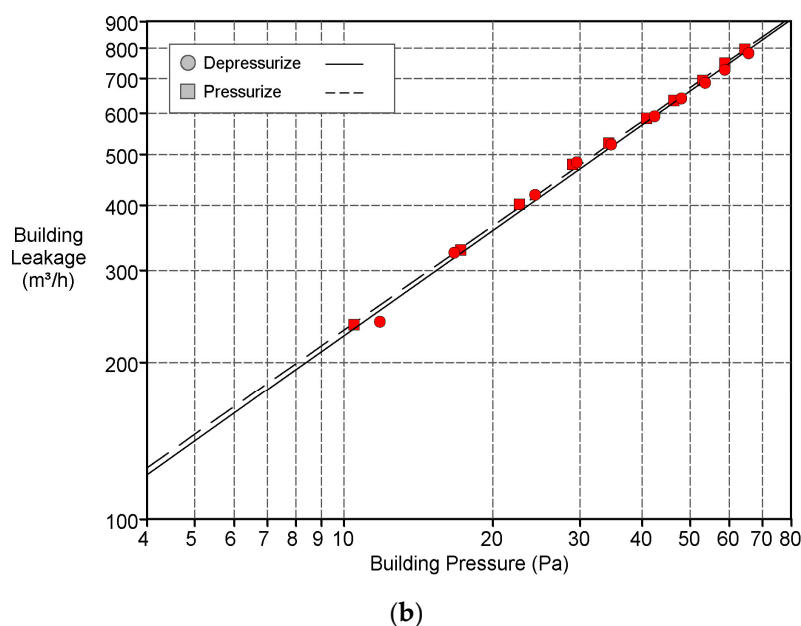
Figure 10. Automated test graph. (a) graph for Method A; (b) graph for Method B.

In order to measure the airtightness of the dwelling, blower door tests are carried out with an automated performance testing system and following the project protocols (Figure 10). Tests were carried out in February 2017 with the environmental conditions described in Table 8. Test results are detailed in Table 9.

The exponent n has a typical value close to 0.67. Consequently, the flow is neither fully turbulent nor dominated by laminar characteristics and the shape of leakage paths cannot be clearly defined.

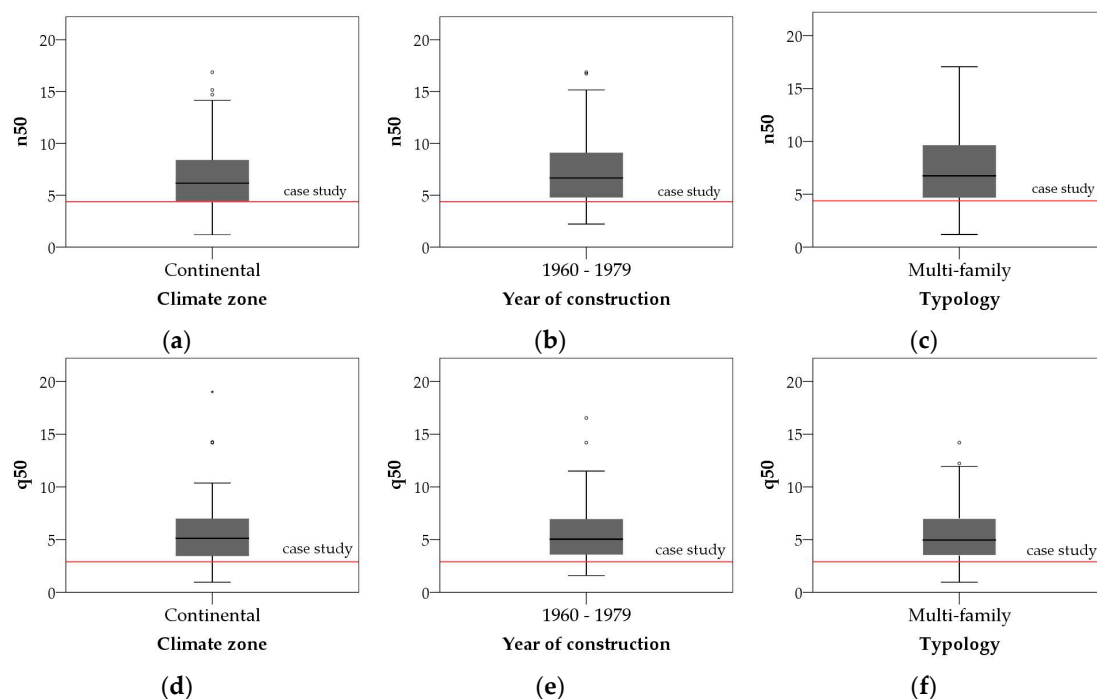
Figure 11. Boxplot of database results compared to the case study results, indicated by the red line. (a) n_{50} for Continental climate zone; (b) n_{50} for dwellings built within the period 1960–1979; (c) n_{50} for multi-family dwellings; (d) q_{50} for Continental climate zone; (e) q_{50} for dwellings built within the period 1960–1979; (f) q_{50} for multi-family dwellings.

When compared to regulations in other European countries, the case study dwelling would comply with UK ($q_{50} < 10 \text{ m}^3/\text{m}^2\cdot\text{h}$) and Ireland ($q_{50} < 7 \text{ m}^3/\text{m}^2\cdot\text{h}$) or Czech Republic ($n_{50} < 4.5 \text{ h}^{-1}$) regulations but not with German regulations nor Polish recommendations ($n_{50} < 3 \text{ h}^{-1}$) for new buildings [49]. The comparison with French regulations has not been made since its indicator is measured at 4 Pa and a direct translation of the results would not be accurate.

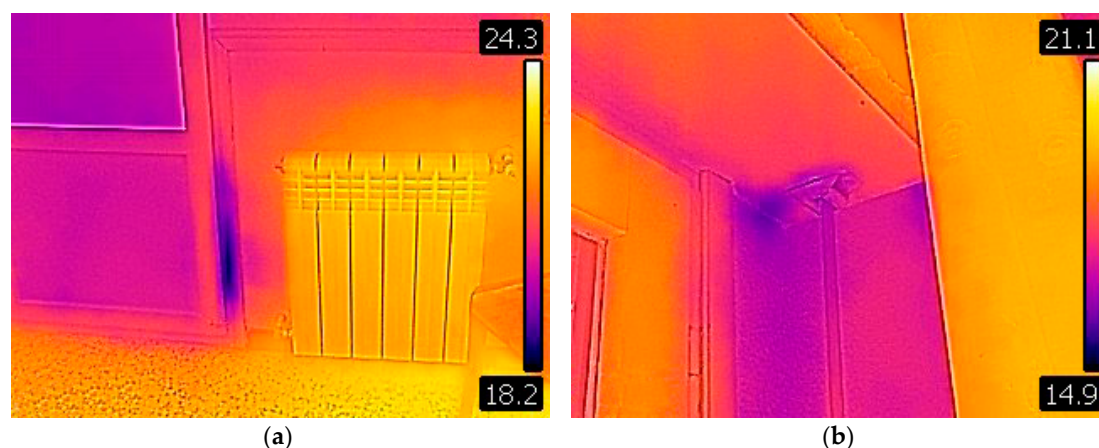
Figure 12. Leakage paths detected with thermography. (a) Leakage path located in a door frame; (b) Leakage path located in the tape guide of the rolling shutter.

To determine infiltration locations and distribution, thermal imaging was undertaken during the depressurization stage. Since there was a great temperature difference between the inside and the outside of the dwelling leakage points were easily visualized. Most leakages were located in window frames and shutter boxes (Figure 12).

A case study in Valladolid has been presented in order to show an example of the implementation of the methodology. Airtightness results are compared to mean values obtained from the database, considering the control variables used to design the sample: climate zone, year of construction, and typology. Results obtained indicate that the dwelling has a medium airtightness level, significantly higher than the mean values obtained from the database. Leakages at the case study were located mainly around window joints and frames and shutter boxes.
